Structural Renovation of Fallingwater

Spring 2004 Arch 631

By: Kayvan Madani Nejad

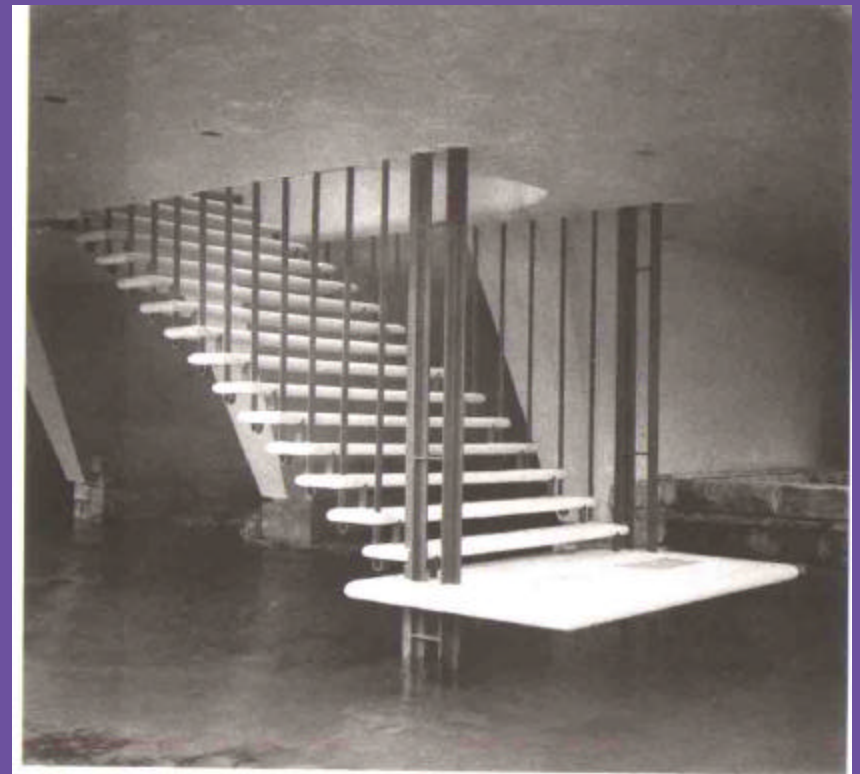
- A force is applied suddenly or changes rapidly
- During storms rocks in river hit the building.
- Steel columns of the staircase to the stream buckled due to impact loads.
- Water levels rise and increase the force applied to the building

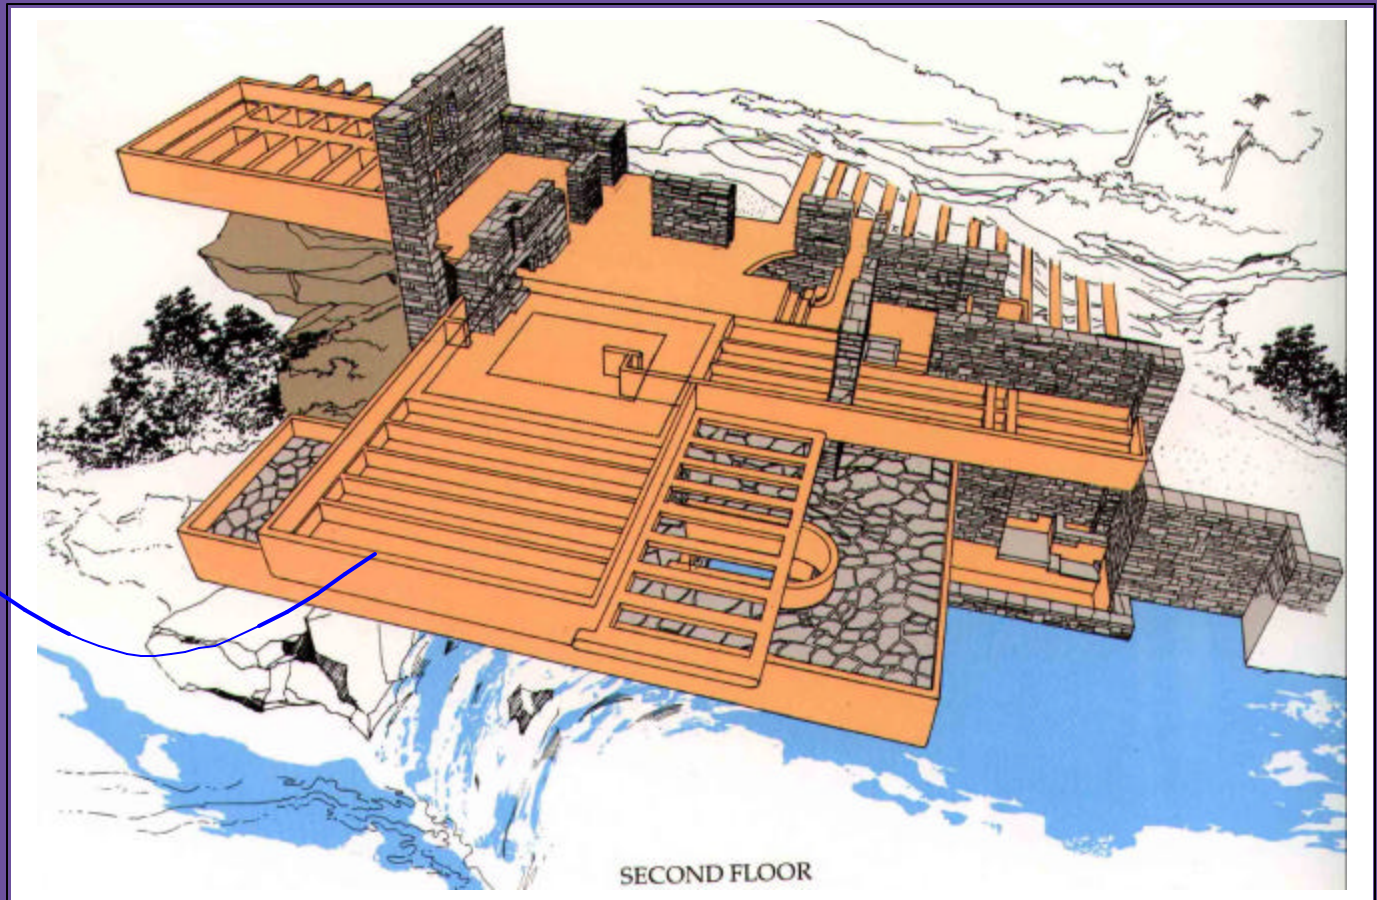
Master Bedroom Terrace: The master bedroom terrace extends an extra 6 feet beyond the first floor terrace. Beside the concrete floor joists and the structural parapets, it is supported by 4 steel window mullions embedded in the first floor parapet.
