FALLINGWATER

PAST-PRESENT-FUTURE

STRUCTURAL ANALYSIS

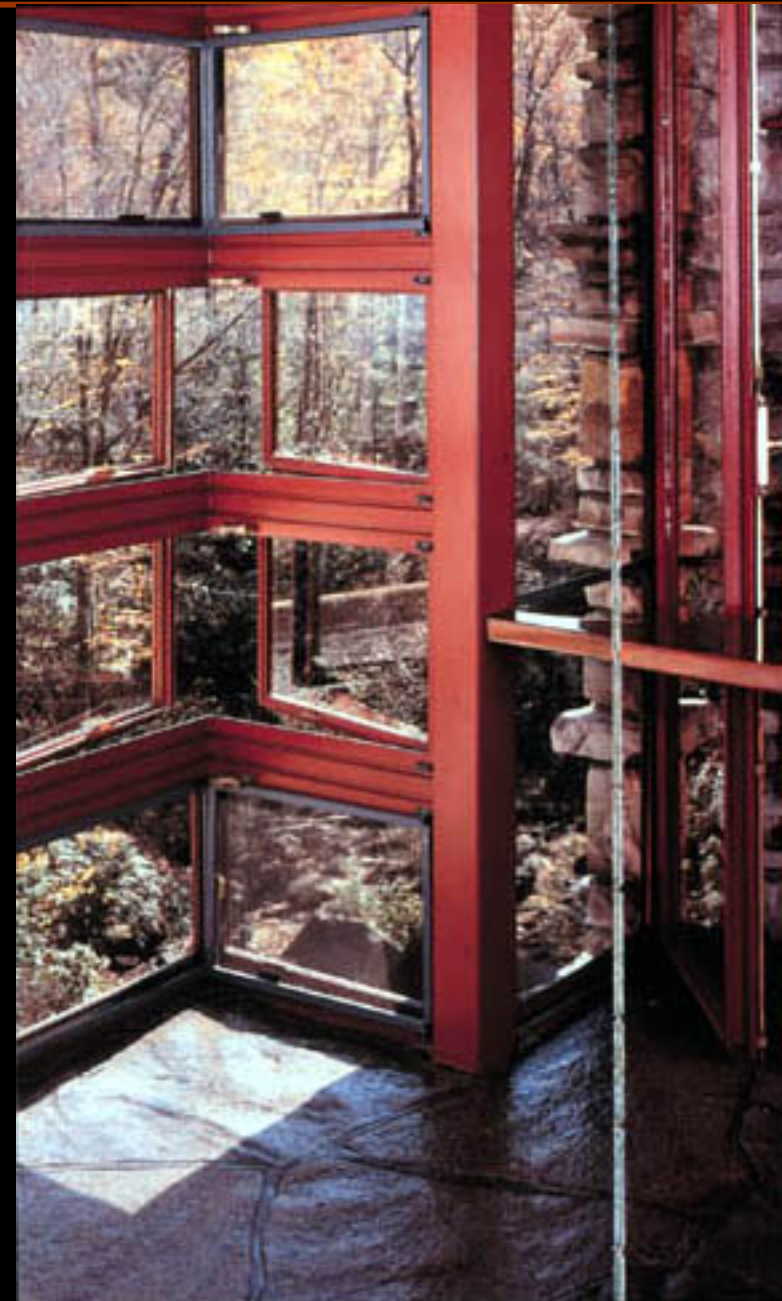
Window mullions which, at first were considered as non-structural elements were found to transfer loads from the upper terraces to the lower terrace.

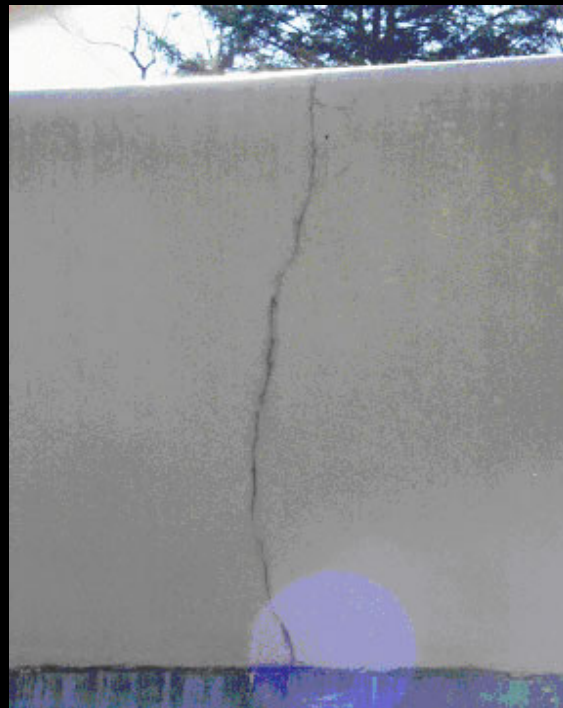
The initial deflection occurred during construction when the forms were not designed to carry the wet weight of the concrete.

The secondary problem was the lack of tensile reinforcement in the beams that carried the first and second story terrace cantilevers. The amount of steel was doubled during construction to sixteen, one inch, steel bars. This still was not enough to carry the load.

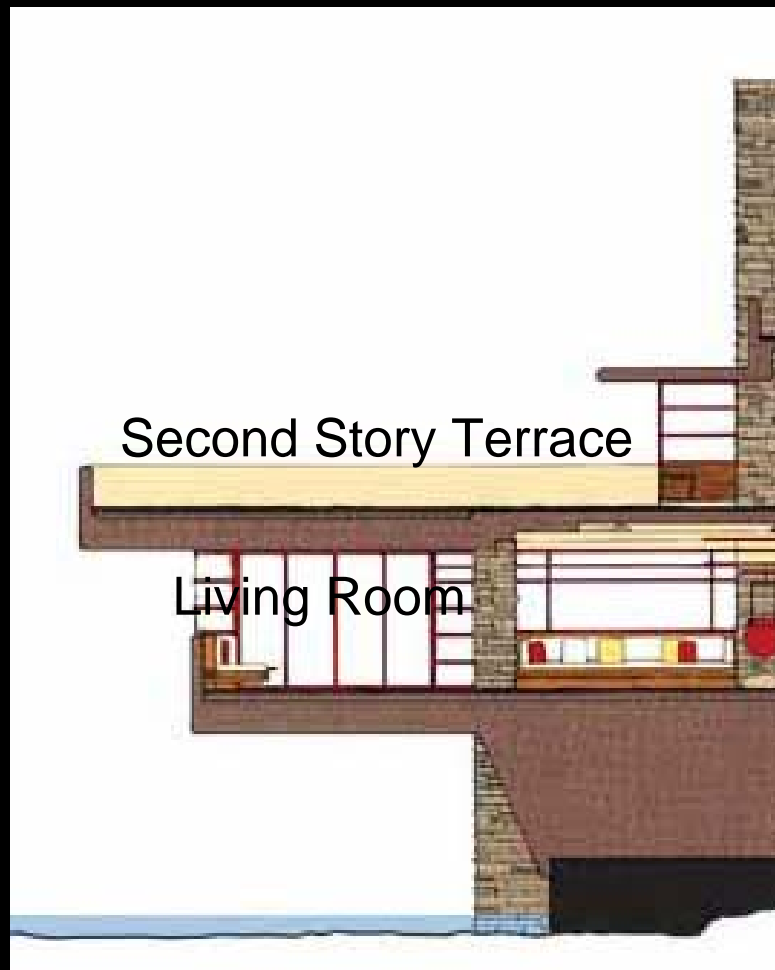
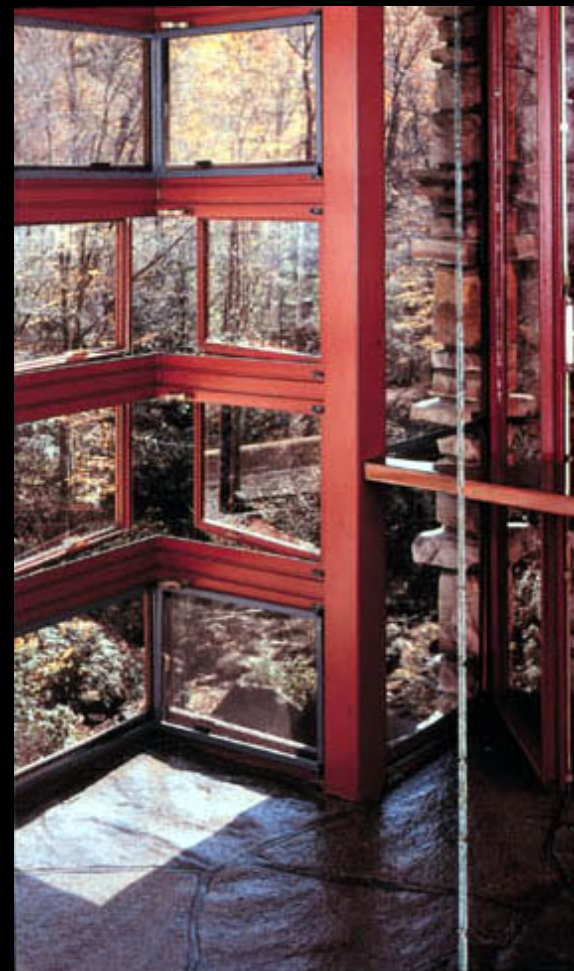
The major problem occurs in the lowest terrace with a fifteen foot cantilever. Because the tensile reinforcement was not adequate for the second story terrace, the living room window mullions transfer the weight downward to the first level terrace. The first level terrace was also insufficiently reinforced and could not support its own load plus the additional weight of the second story terrace.
