Basic Info:

Home of the Texas A&M Men's and Women's Basketball Teams

Unique Design:

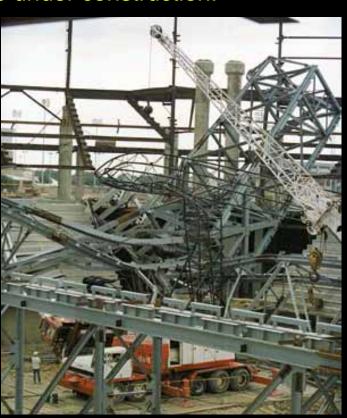
- -"Table Top" Box Truss
- -Composite columns: Concrete with

W14 steel sections

- -Petrified Palm Trees found underneath the site.
- -Underground Spring.
- Truss system supports both the catwalk and equipment rigging

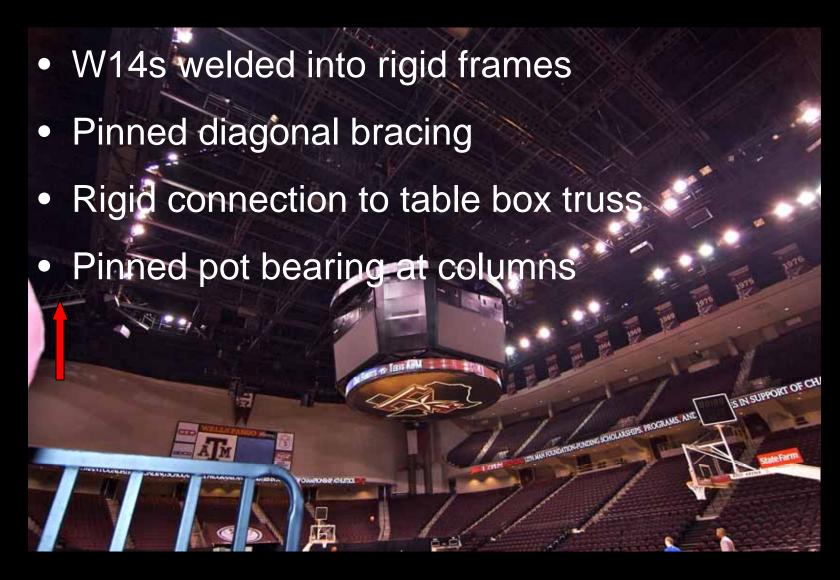
Leg Truss

Gusset Plate

Cross Bracing

Stiffening Plate

Welded W14

4'-0" diam. Base Plate

10" diam Pipes

Knuckle Joint

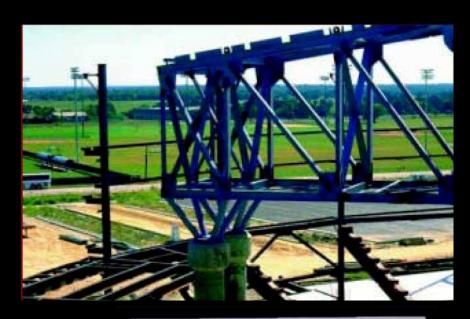
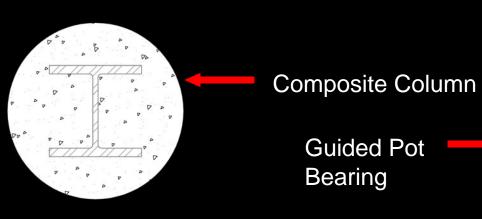
- Columns connect to belled and under-reamed piers
- Under-reaming spreads the columns load and resists uplift from clay soil
- Steel base plate is covered with concrete cover.
- Soil berm from pouring is left until expansion is needed
