Case Study:

Guggenheim Modern Art Museum, NY

ARCH 631: Structural Systems
Prof. Anne Nichols
2011

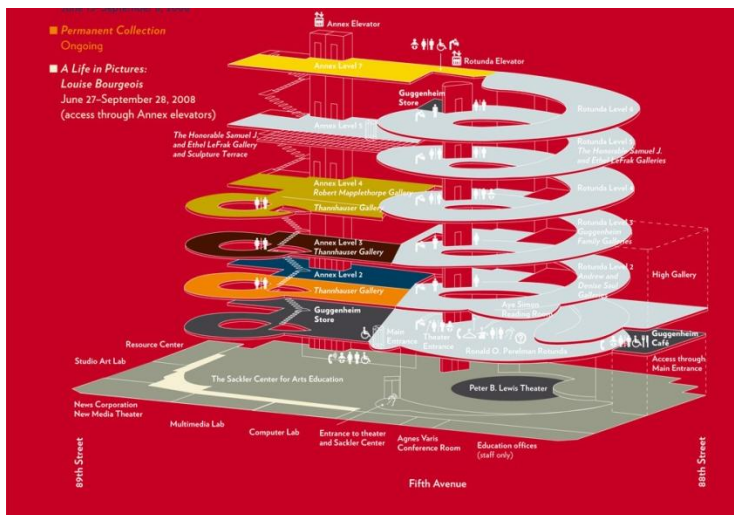
Building Layout: Annex

- Ten story limestone clad.
- Constructed in 1992. It was an extension of the four story annex built in 1968, the present structure occupies the same footprint and incorporates the foundations and framing of its predecessor.
- Four floors of exhibition space, three of which are double height, also has office and storage space for mechanical systems.

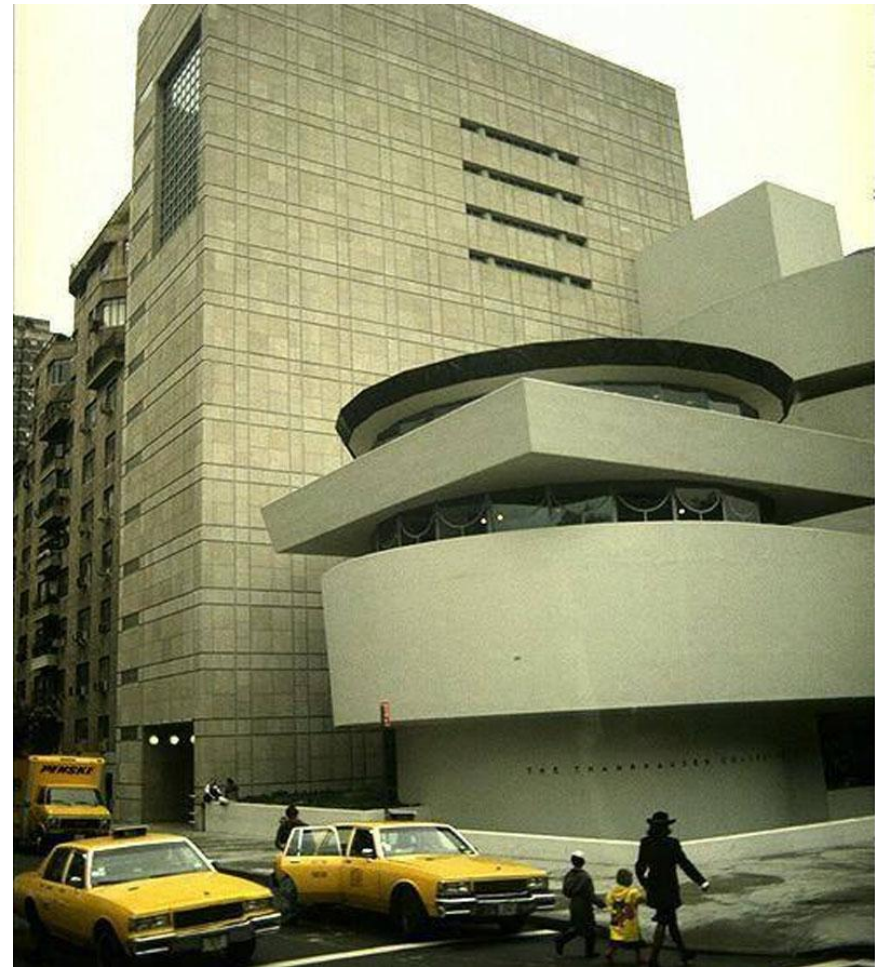
Building Layout: Rotunda

- Twelve radial web walls divide the gallery into 70 bays for viewing artwork.
- A large glass dome covers the entire rotunda, providing natural lighting inside the gallery.
- Skylights line each level of the rotunda, providing natural light along the periphery.
- The gallery walls are 9'6" tall and slope slightly outwards at 97 degrees from the floor.
- Designed to hold paintings, the tilt of the gallery walls was intended to replicate the slope of an easel.

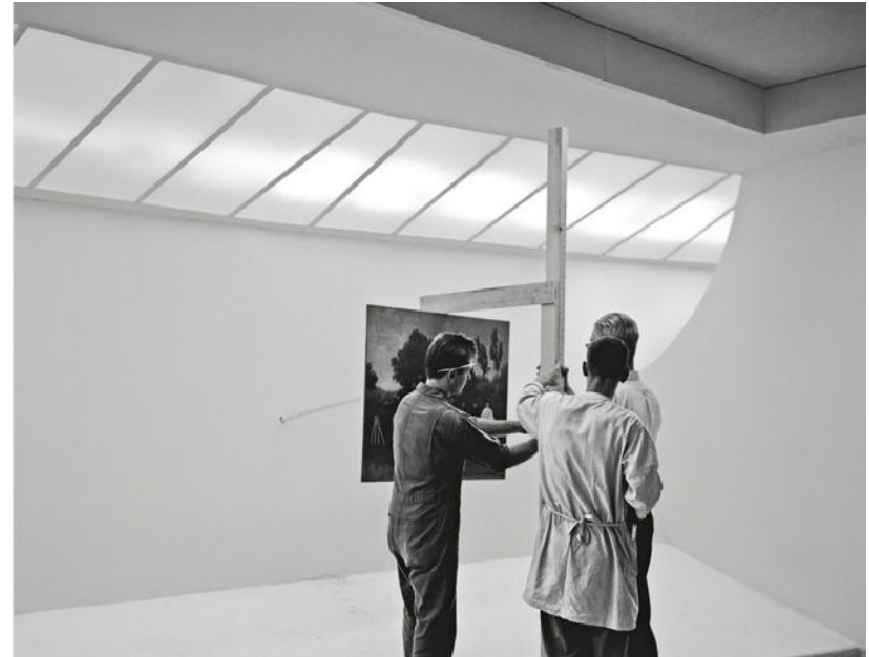
Building Features: Lighting

- skylights: originally intended to illuminate the painting in natural light, but were changed to artificial to have more controlled lighting
- The lower image illustrates the 70 bays that the web walls create

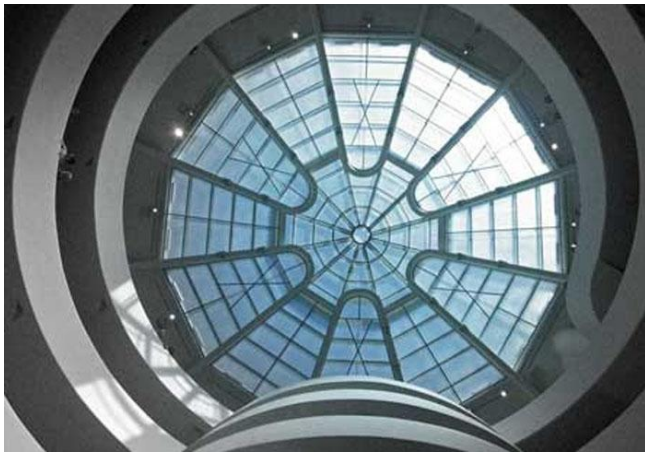
Building Components and System

- Glass dome with aluminum frame
- 12 ribs, coinciding with the 12 radial “web walls”
- The web walls connect at the roof level forming hairpin beams that support the massive central skylight.

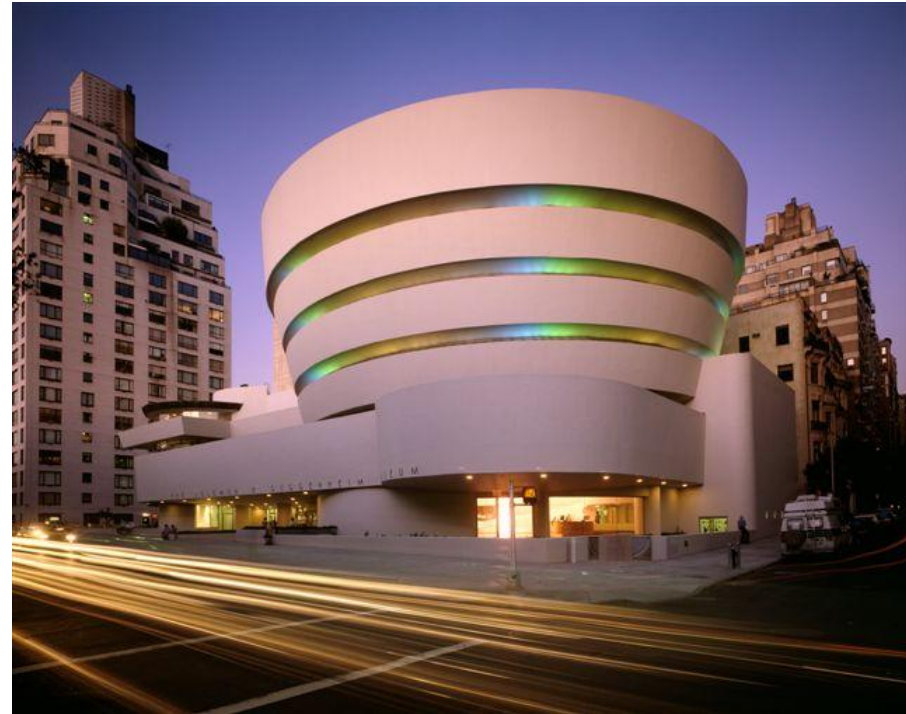
Materials: Guniting

- Guniting (shotcrete): a mixture of concrete and sand that is sprayed through a metal mesh with wooden formwork.
- The reinforcing of the shotcrete consists of vertical and horizontal steel bars sandwiched between two layers of welded wire mesh.
- The curved walls are constructed of shotcrete (guniting) which was sprayed onto plywood forms secured every 10 degrees to vertical steel Tees embedded in the walls.
- Shotcrete walls are 5 inches thick.

- The Guggenheim is primarily composed of reinforced concrete.
 - Normal weight cast in place concrete is the material of the lower levels.
 - light weight concrete is the material of the interior radial walls and the ramps.
- Guniting, or shotcrete, is the material used for the exterior of the spiral curved walls.
- Wright used guniting to achieve a seamless monolithic façade.
- Wright left out expansion joints, which would have created visual vertical breaks. He hoped the application of elastomeric paint, known as the “cacoon” would fill in the cracks formed during construction.
- The pairing of multiple types of concrete caused visible cracks in the façade.
- Steel framed windows
- Aluminum skylights
- Cement plaster soffits on metal lath.

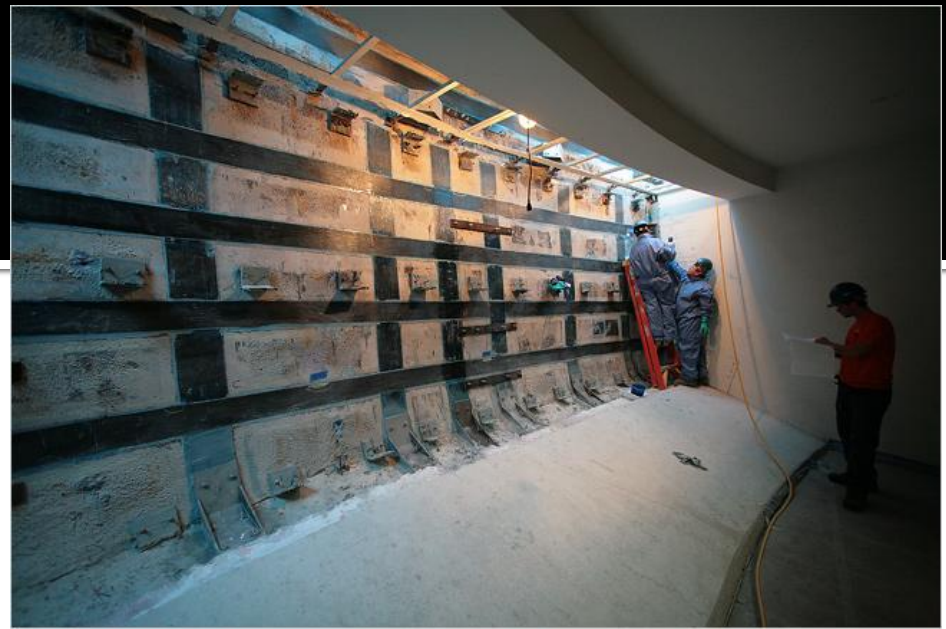
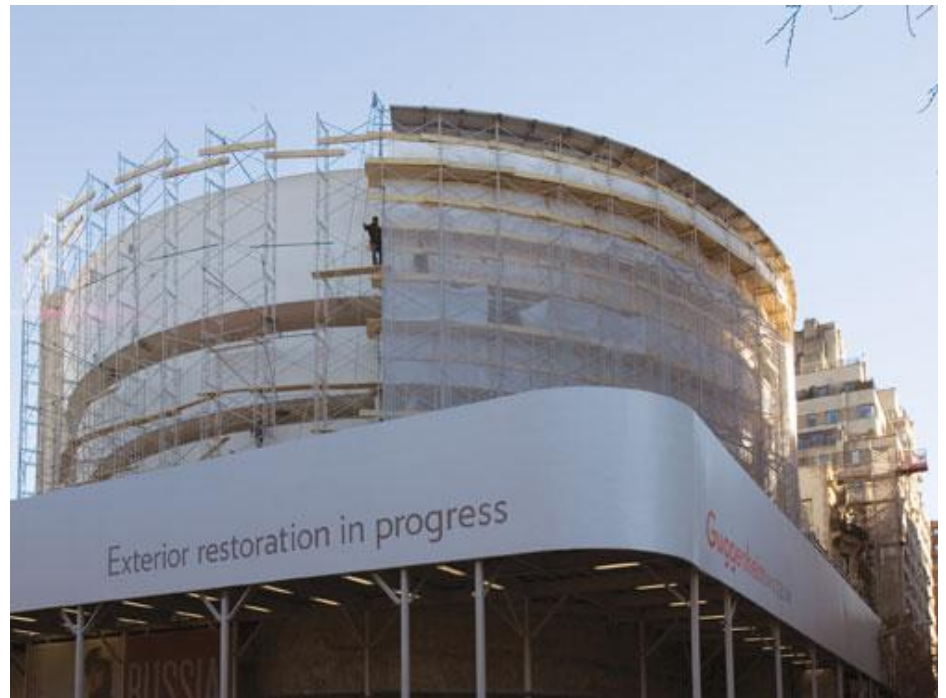
Restoration

- From December 2004 through September 2008, the Solomon R. Guggenheim Museum underwent its first major restoration.
- The sixth floor ramp walls were structurally reinforced with a basket-weave pattern of carbon-fiber reinforced polymer (CFRP) applied to the interior surface.
- Carbon fiber strips restore tensile capacity to deteriorating ramp walls yet meet architectural aesthetic and preservation requirements.

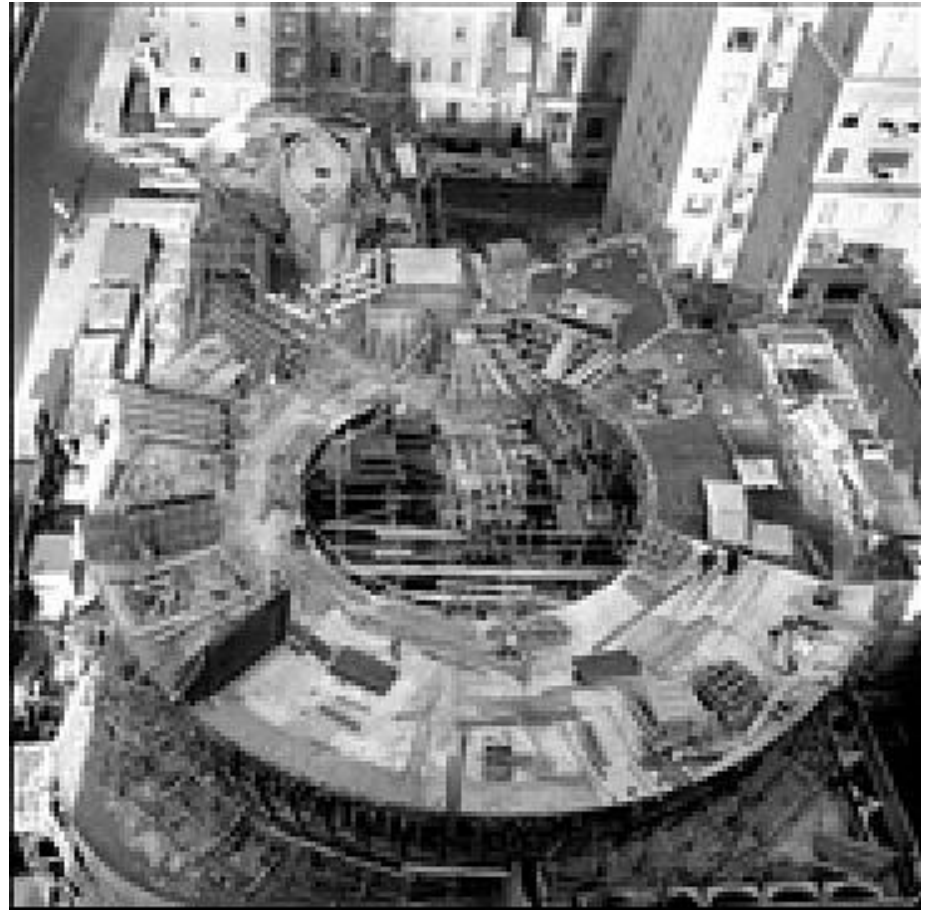
Building Components: Constructed

- Cast in place concrete for the floor slab and shear walls; reinforced concrete
- Each ramp section was constructed first then the “web walls” were put in place
- The exterior walls were constructed last by the gunite process

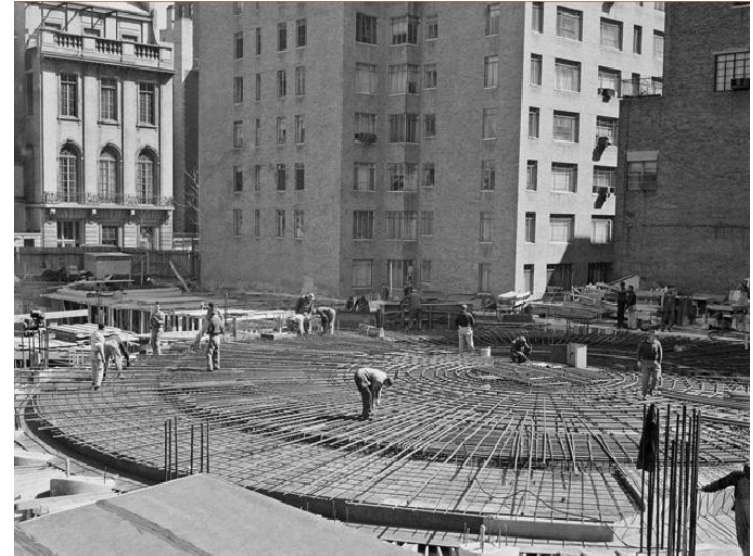
Building Components: Foundation

- Because the soil is easily drained, it allows for an underground level.
- Underground level contains a theater and bookstore which is outlined with thick load-bearing concrete walls.
- There is a deep foundation with a basement wall footing that encloses a basement space and it is restrained by a top floor slab of reinforced concrete.
