FALLINGWATER

PAST-PRESENT-FUTURE

STRUCTURAL ANALYSIS

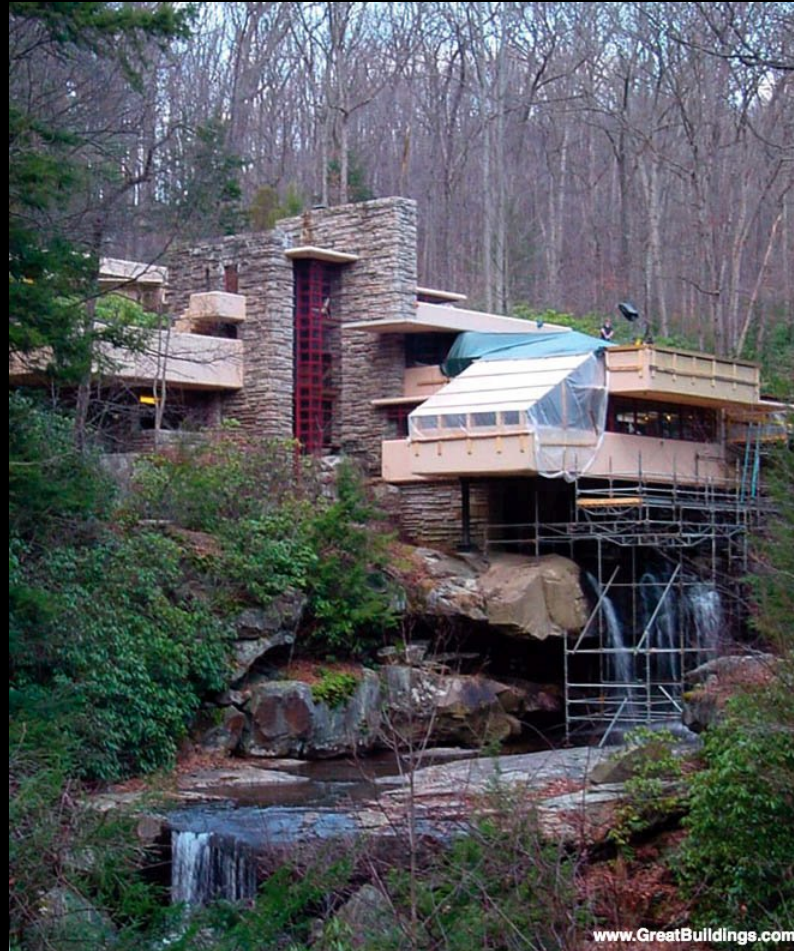
STRUCTURAL FAILURE

PROBLEMS

The initial deflection occurred during construction when the forms were not designed to carry the wet weight of the concrete.

The secondary problem was the lack of tensile reinforcement in the beams that carried the first and second story terrace cantilevers. The amount of steel was doubled during construction to sixteen, one inch, steel bars. This still was not enough to carry the load.
