KEILLER BUILDING

Laboratory Building
University of Texas -- Medical Branch
Galveston, Texas

Team "That's What She Said"

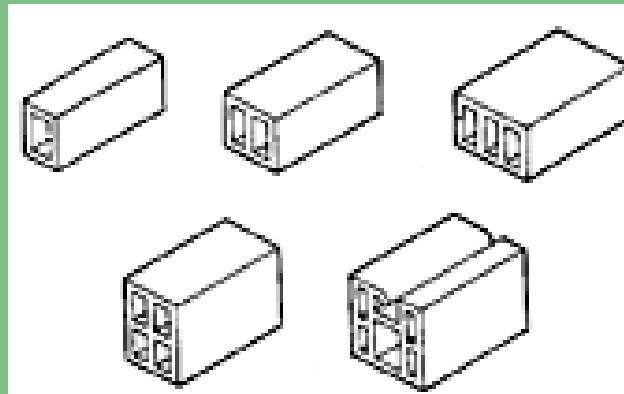
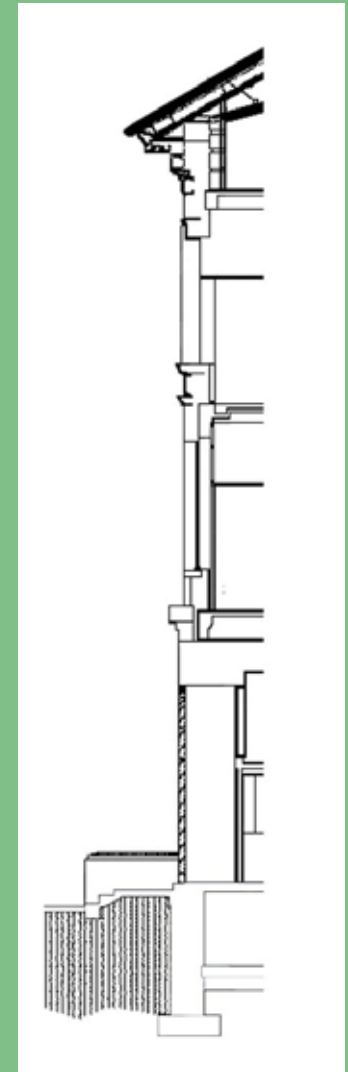
- Massing

- Primary system is load bearing masonry consisting of 1' clay tile masonry units with limestone and brick veneer (non load-bearing)
- No expansion joints
- Renovation/new construction uses more cast-in-place reinforced concrete, but the overall building system is still primarily load bearing clay masonry.

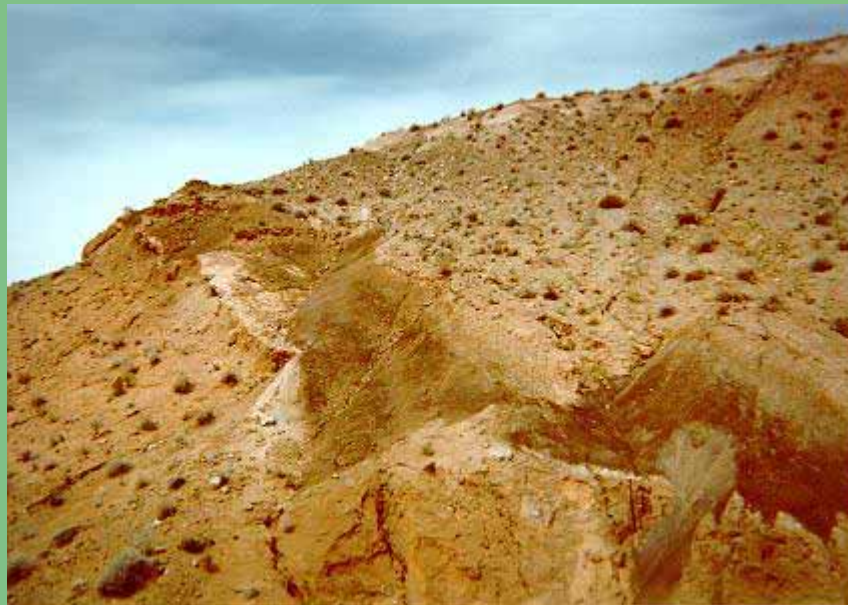
- Soil conditions

- Deep Sandy Eolian Sands of Holocene age.₅
- Cohesionless
- Building should be built upon piers or piles in order to create stability.

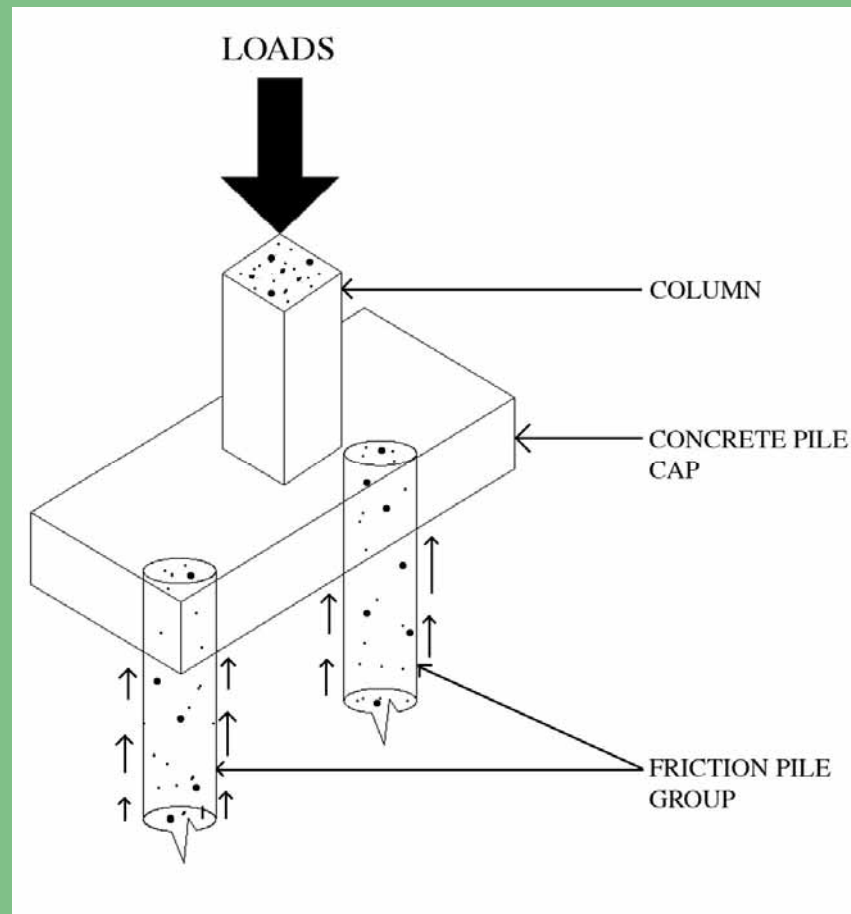
- Foundation

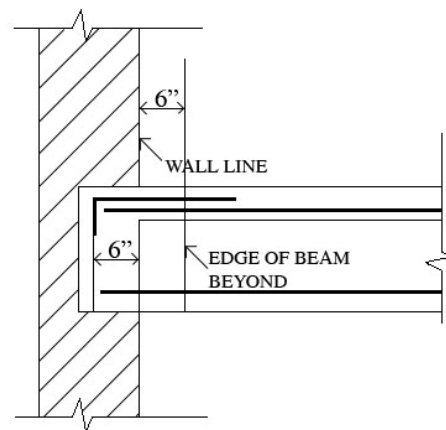
NORTH WALL

- Floor slabs are a one-way concrete joist system in most areas. Slabs are 5" thick, joists are 1' deep and spaced 3' on center
- Some of the longer slab areas have tertiary members to reinforce the system. Visually the slabs become a two way system, but the bay proportions exceed the maximum aspect ratio, making them one-way.

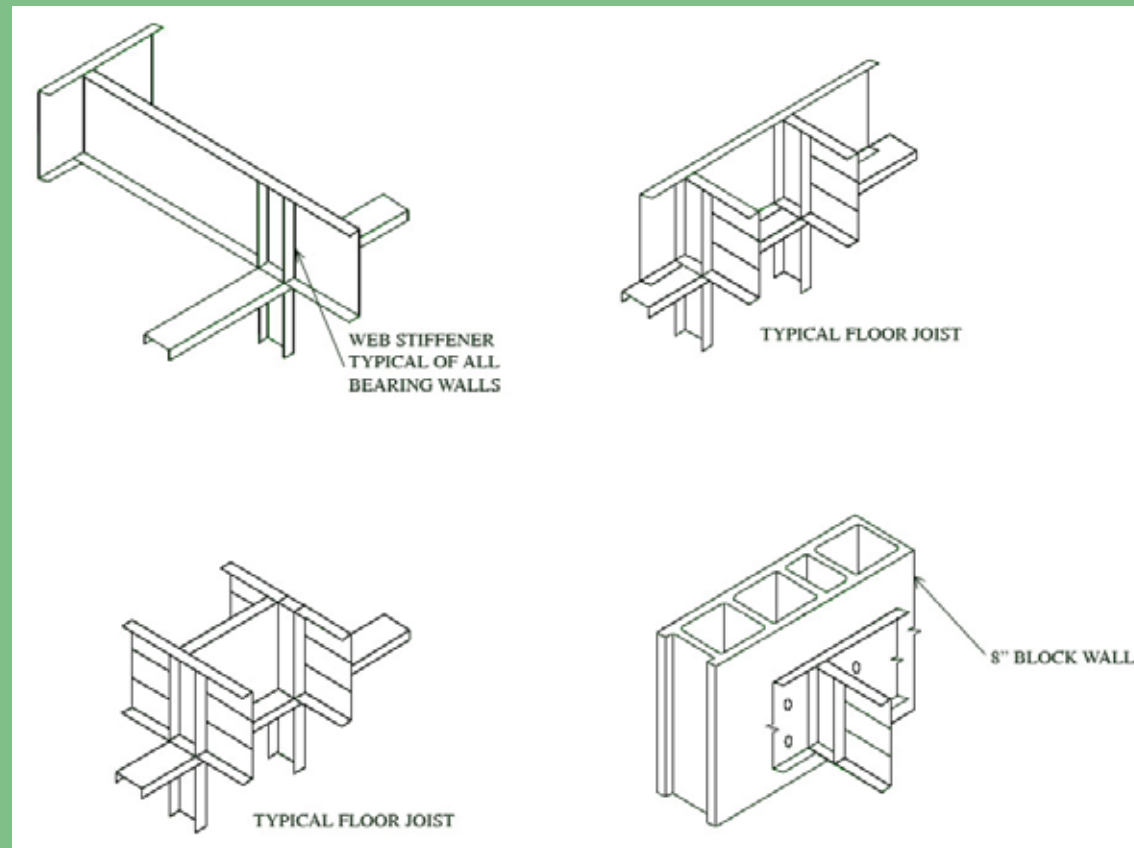
- Flooring (cont.)

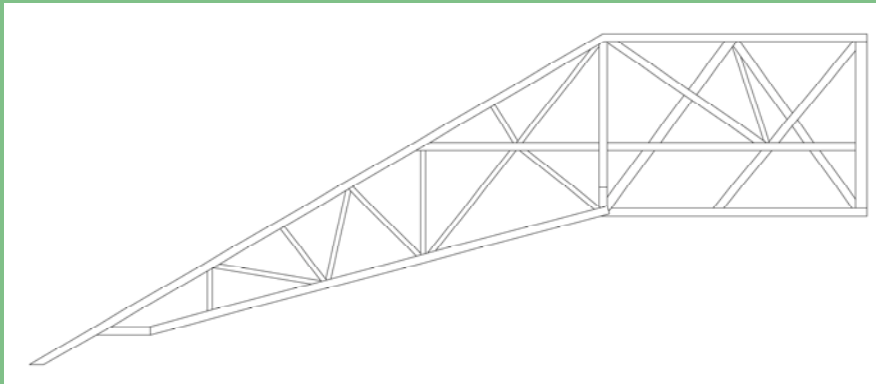
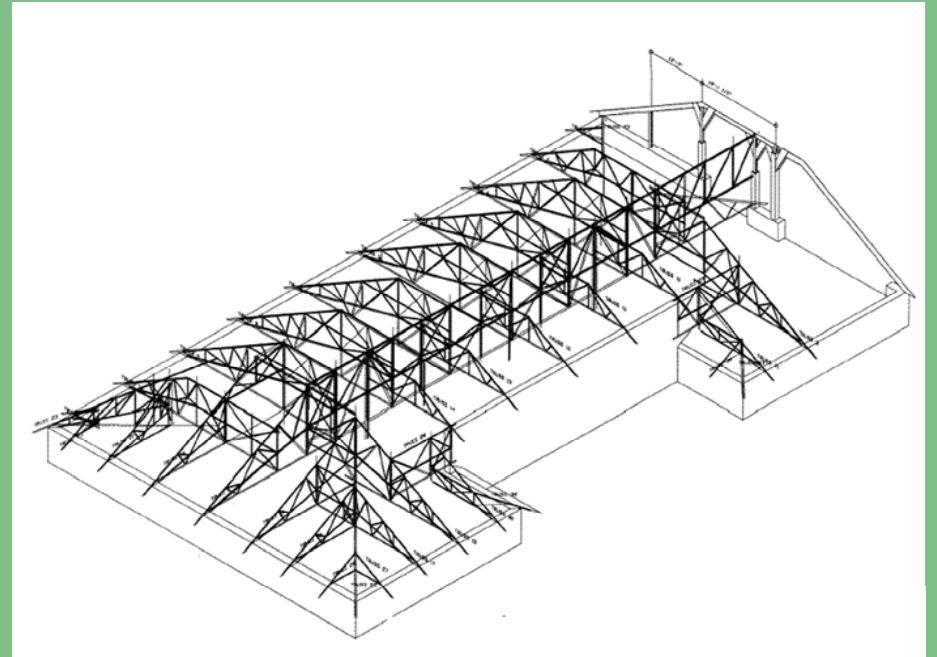
- Roof system

- Roof trusses are formed of welded steel members.
- Composed of two steel angles with a gusset plate connections.
- Rigid joints.
- Truss welded to plate cast in masonry wall.

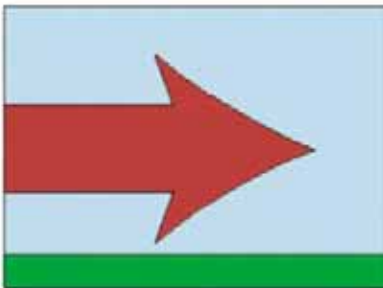
Lateral load: Forces applied parallel to level ground surface. (wind, seismic, backfill, etc.)

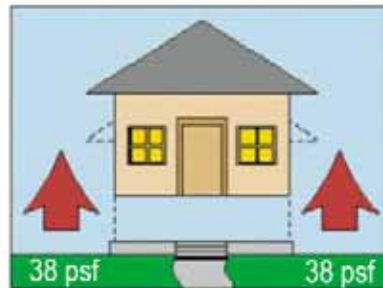
Uplift: Forces applied perpendicular to level ground surface, in an upward direction. (wind uplift and vertical seismic forces)

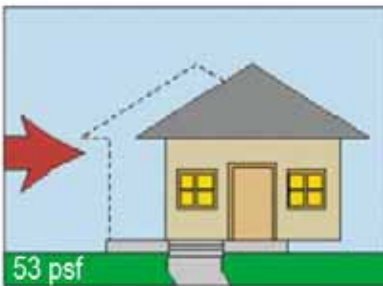
Base shear: The reaction at the base of a wall or structure due to an applied lateral load - "Sliding Force"

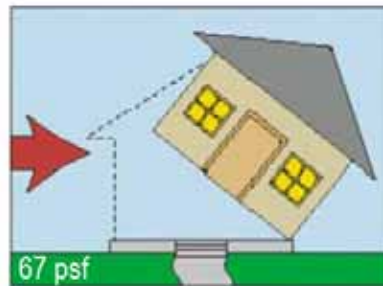
Overturning: What happens when a lateral force acts on a wall or structure and it can't slide - "Tip Over Force."

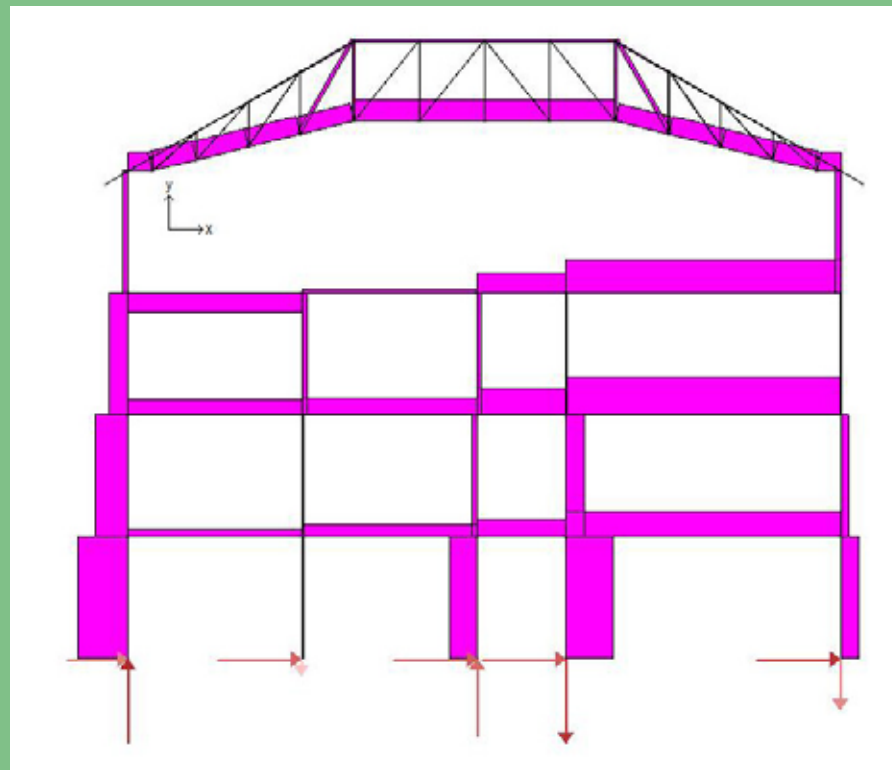
- Loads
 - Force Diagram

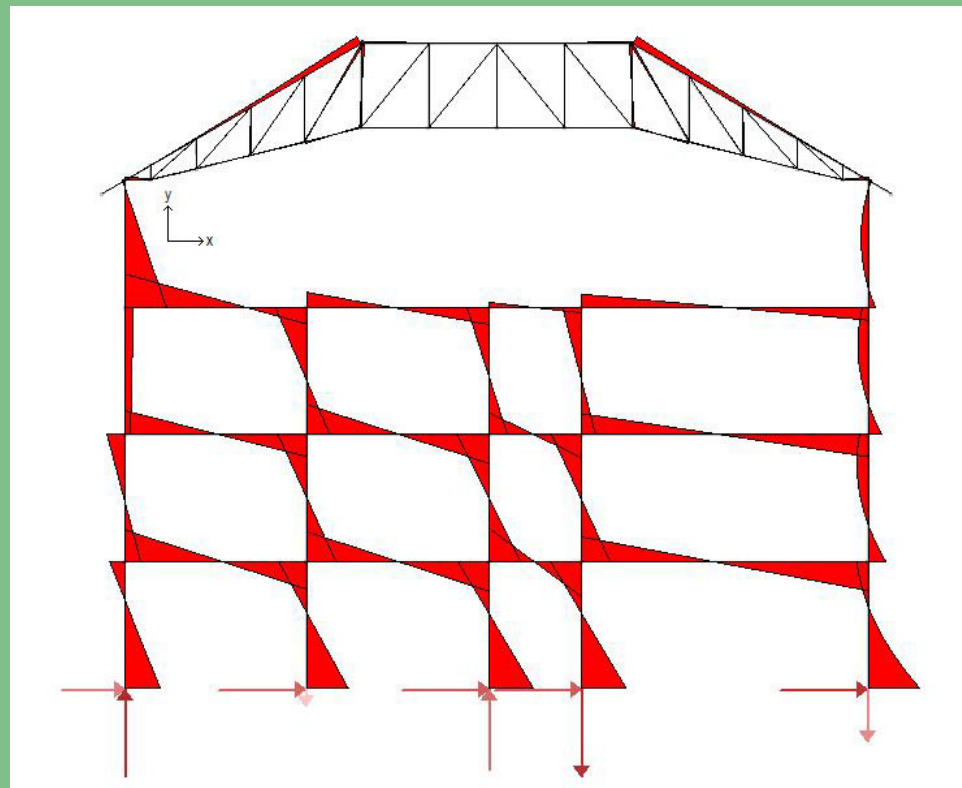
- Loads
 - Moment Diagram

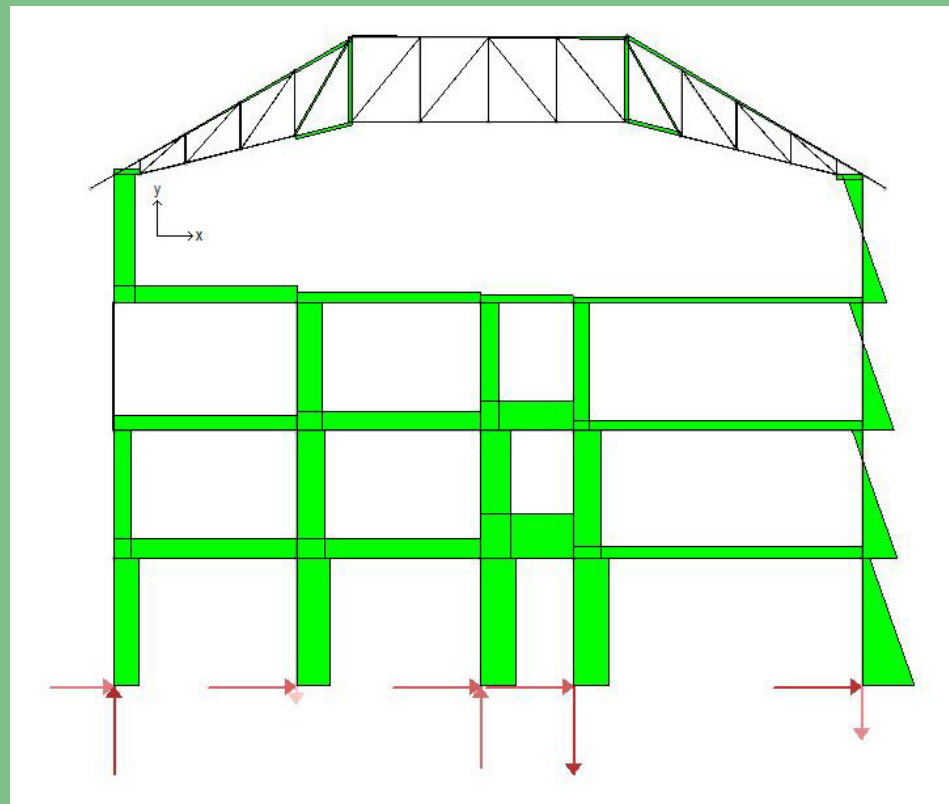
- Loads
 - Shear Diagram
