**Examples:
Membranes, Nets & Shells**

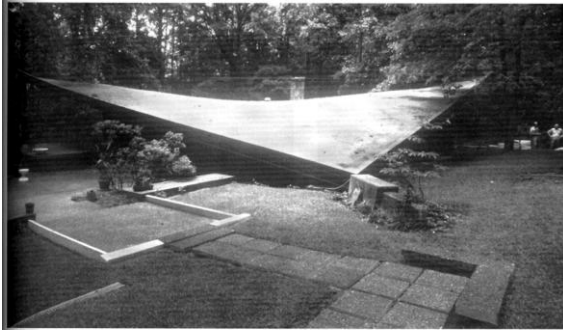
Figure 8.260 Residence with hyperbolic paraboloid roof, designed by architect Eduardo Catalano, in Raleigh, North Carolina.

Investigate with computer modeling the stresses and behavior of a hyperbolic paraboloid under uniform roof loading with column supports away from the edges, as actually built for a residence with glazing between columns. (Ref. Architectural Structures, Wayne Place, 2007, Wiley, NJ.)

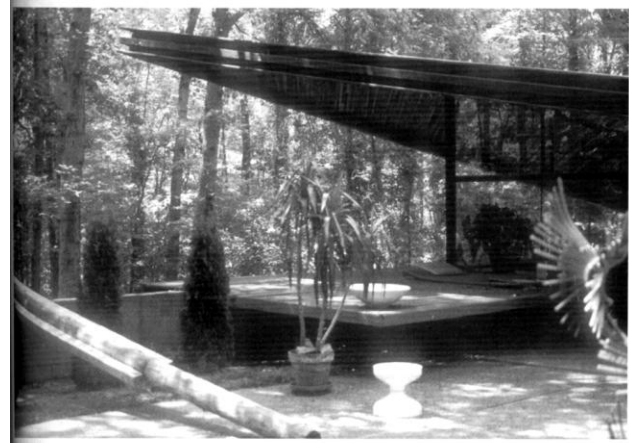
Figure 8.261 Residence with hyperbolic paraboloid roof, showing the ample overhang of the roof, the boundary members, and columns in the glass walls.
